# WHEELER

# CENTRAL

## FACILITIES ASSESSMENT

May 20, 2025

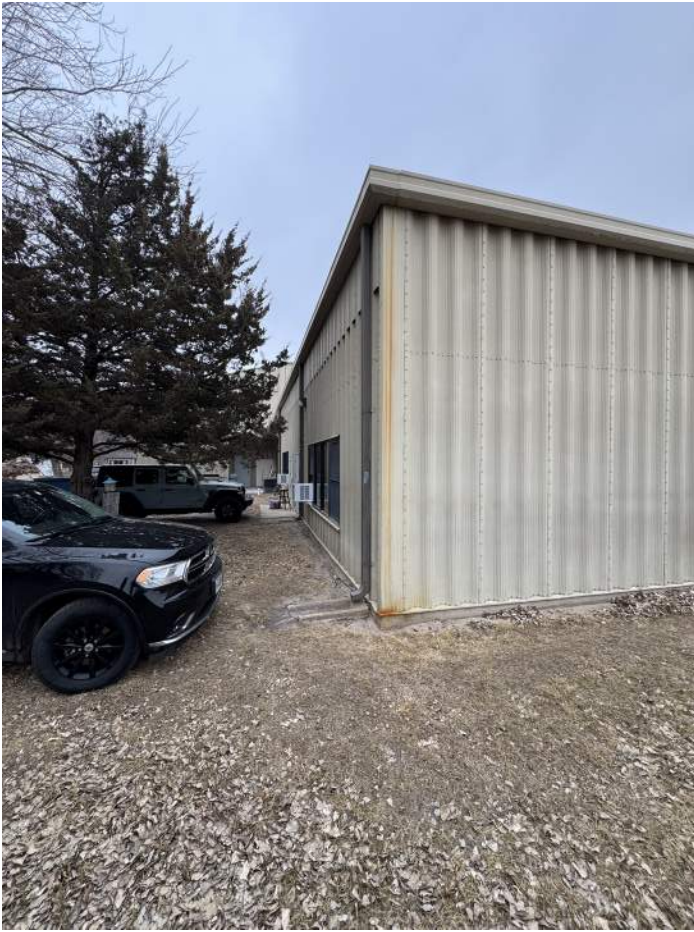
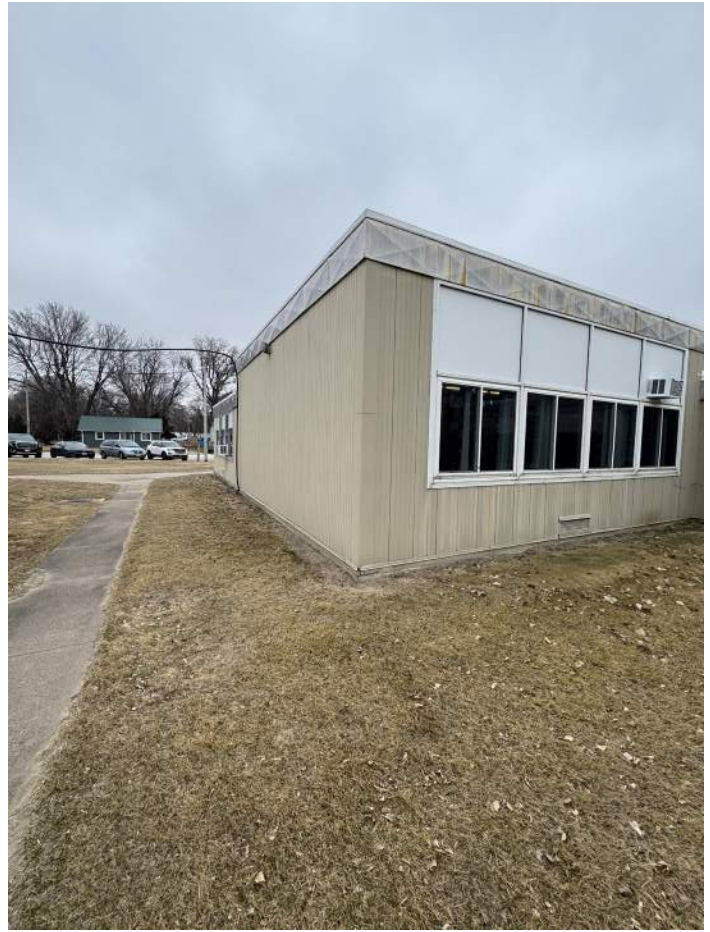
South Building

The concrete sidewalks in some instances are old or cracked.

Replace concrete sidewalk.

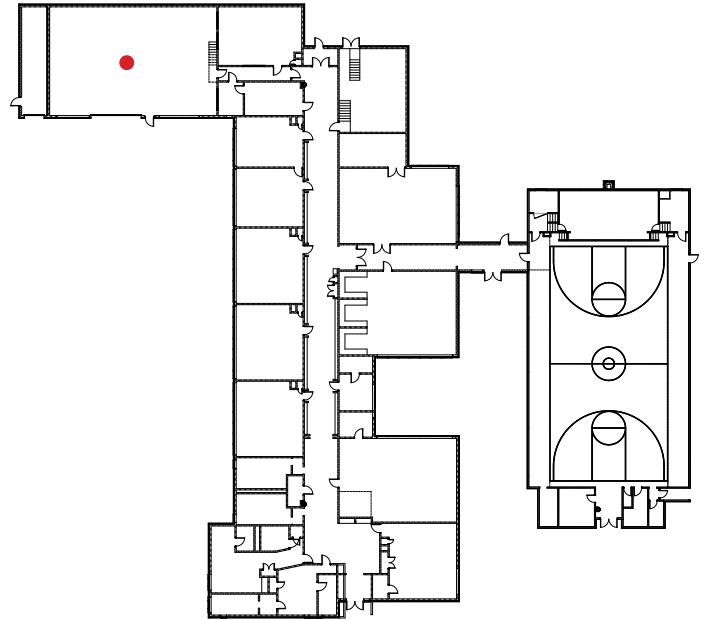
There are multiple exit locations that have damaged or missing exit signage.

Replace all damaged or missing exit signs to comply with the current code. Test existing signage for illumination.

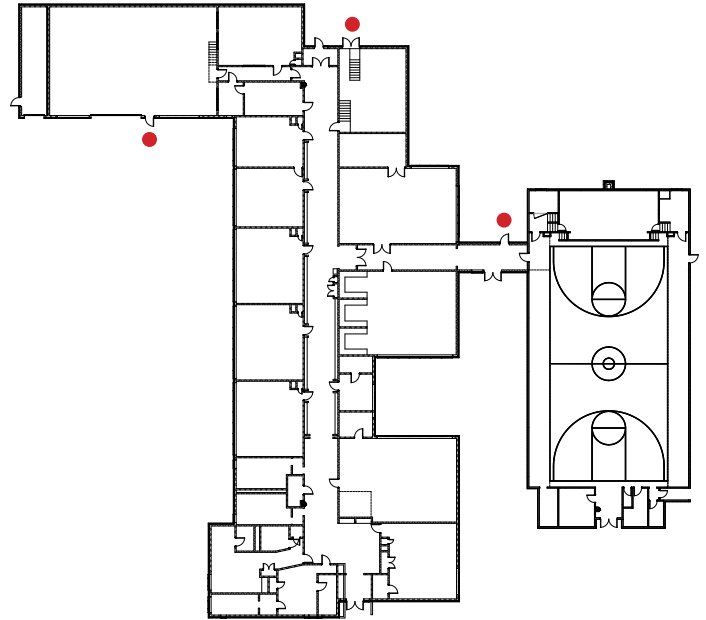
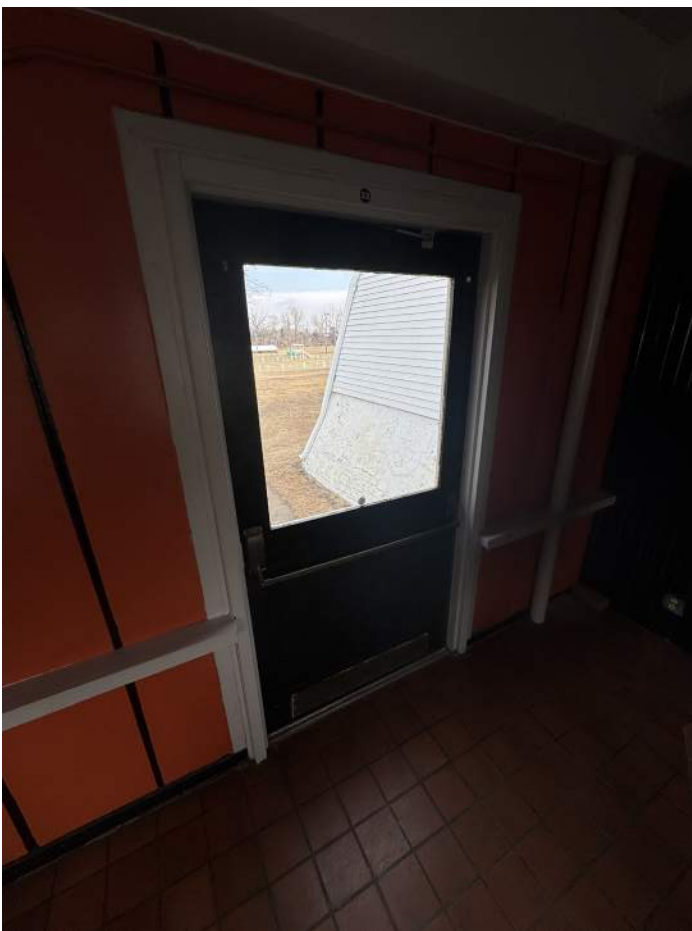
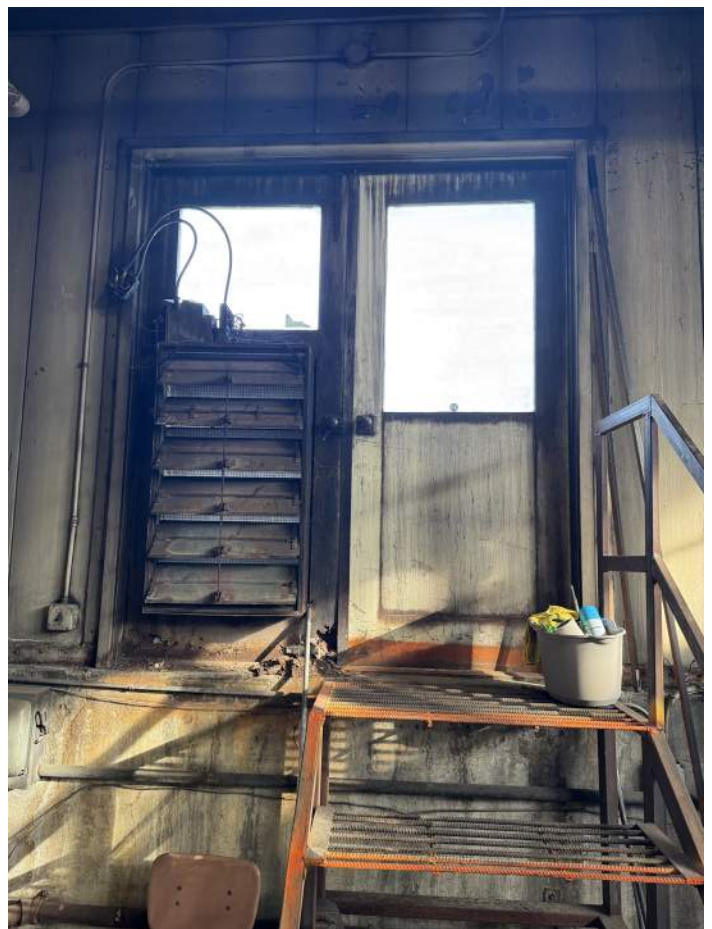
An existing exit door in the high school is blocked with what appears to be a metal security bar. This is a fire code violation when the building is occupied.

Remove security bar restricting proper exiting from the building.

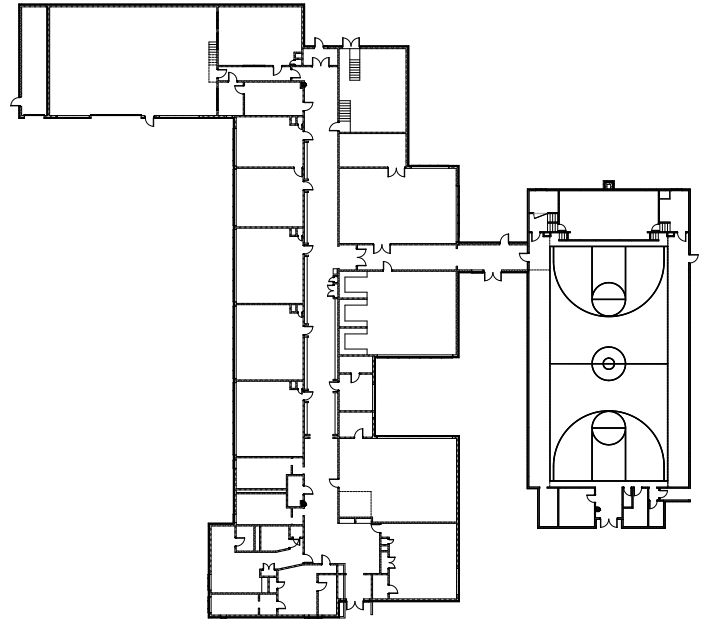
Stormwater appears to collect in a small area in between the old High School Gym and the High School along the sidewalk. Not only does the water pond over the sidewalk but it has caused the sidewalk to heave/displace in this area.

Install a drainage system or create a better channel for runoff to flow away from the buildings in this location. Replace or re-level concrete sidewalks to create an even walking surface.

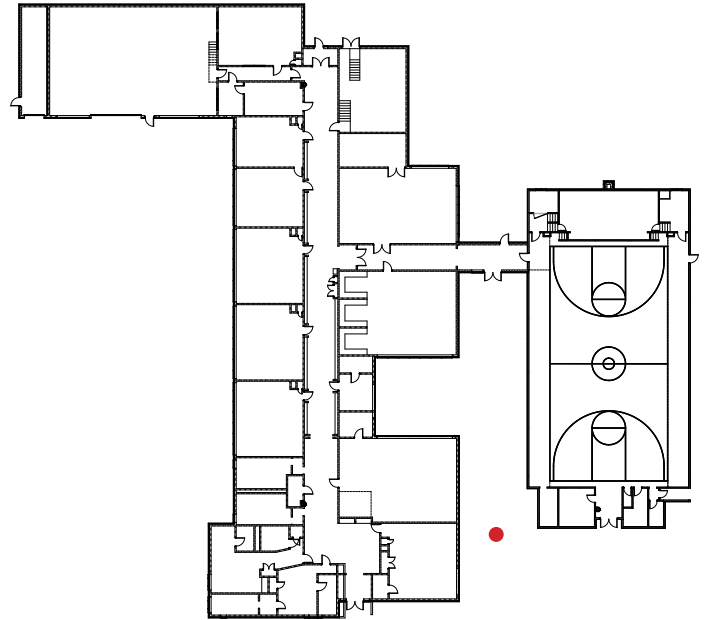
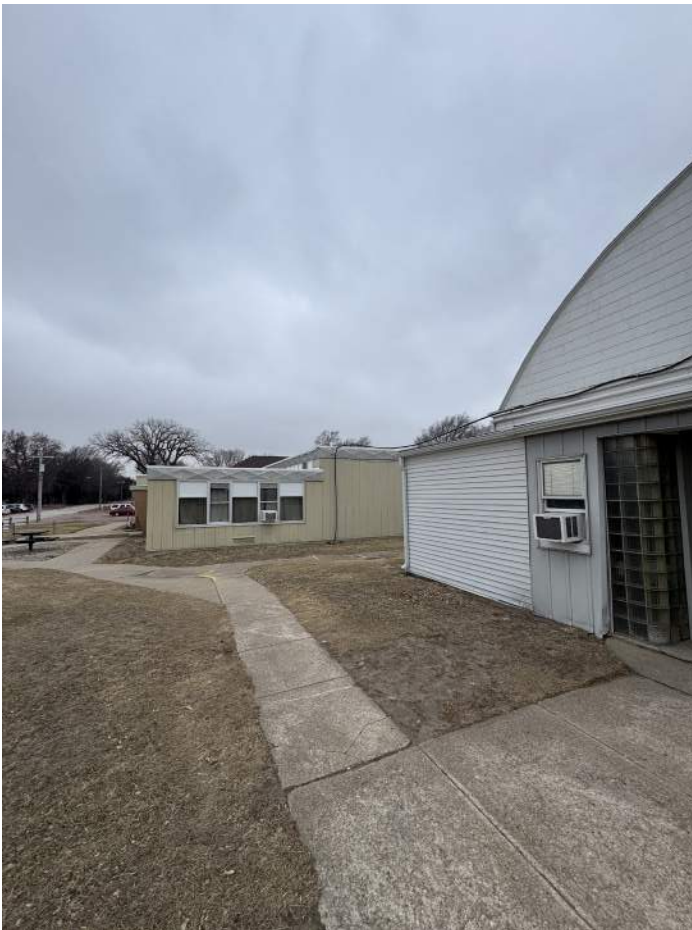
There are several instances of uninsulated, non thermally broken single pane windows.

Replace all single pane windows with double pane windows.

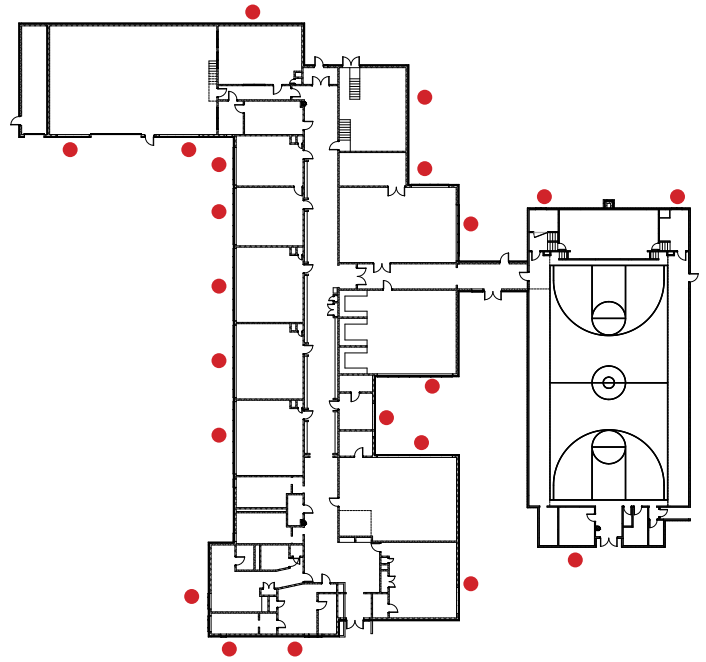
There are two instances of cracked mortar along CMU.

Clean cracks and seal.

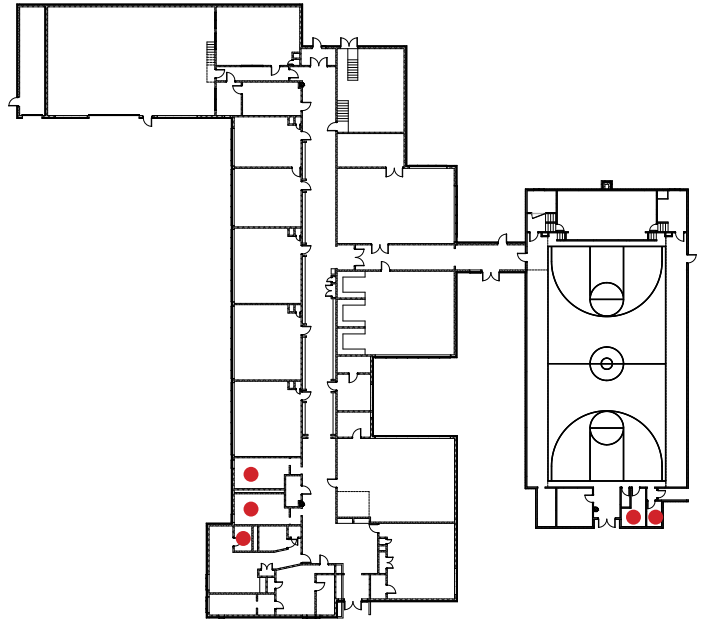
A majority of the acoustic ceiling panels in the high school building are damaged, stained, sagging, or missing.

Replace ceiling panels in their entirety.
