# WHEELER

# CENTRAL

## FACILITIES ASSESSMENT

May 20, 2025

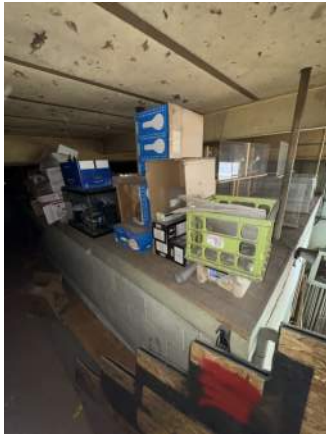
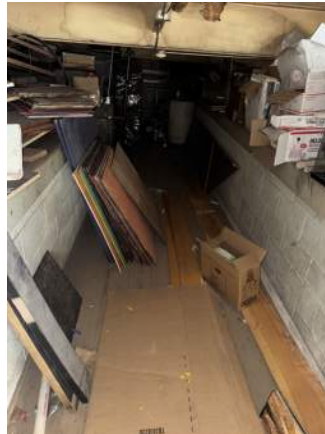
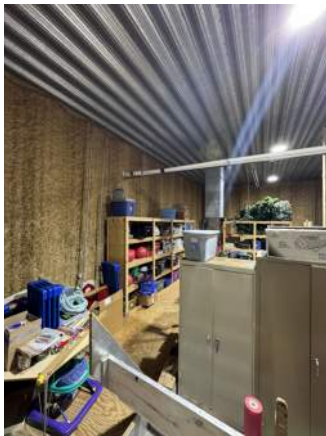
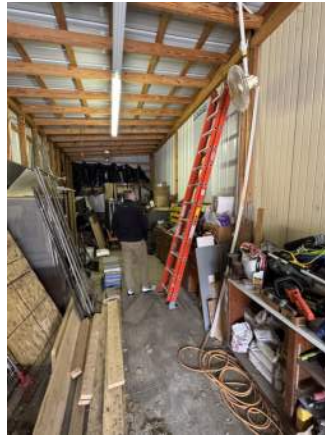
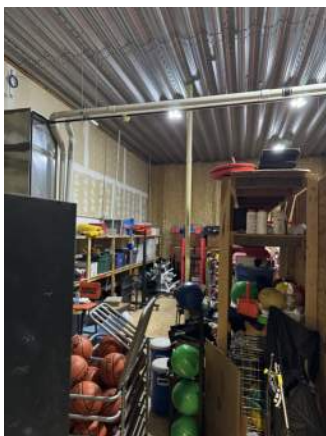
Storage space seems to be at a premium.

Consider adding storage space.

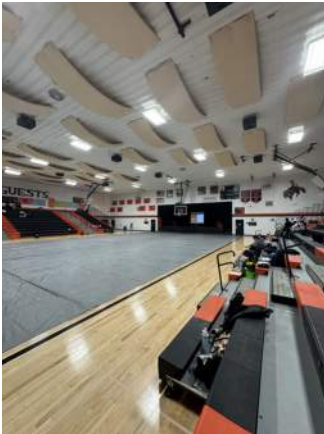
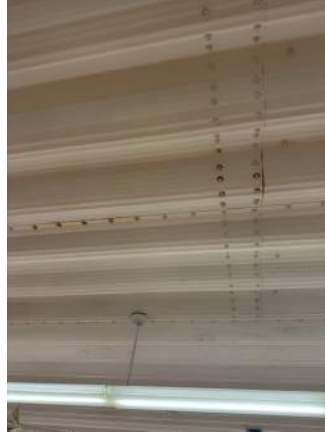
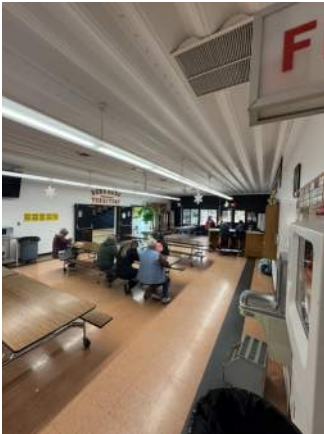
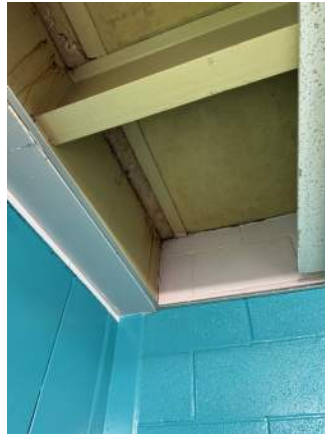
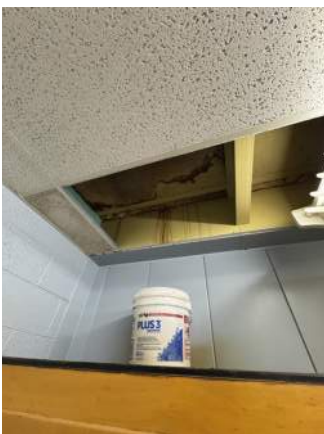
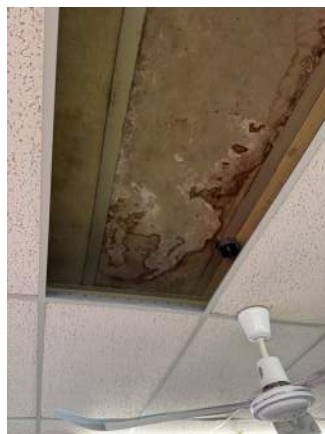
Throughout the campus, there is evidence of several roof leaks.

Repair roof leaks.

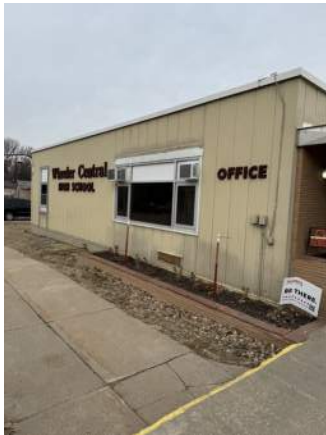
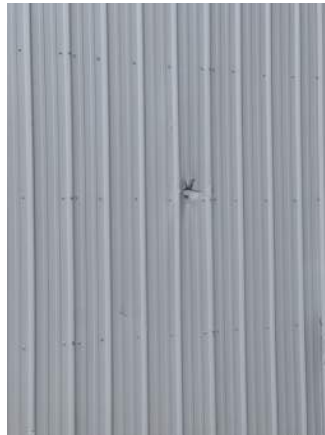
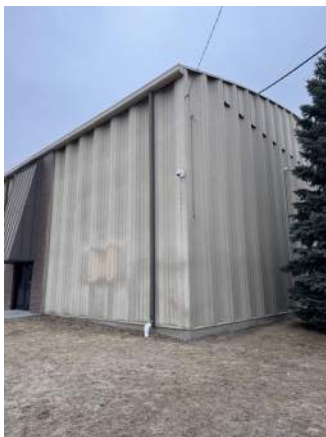
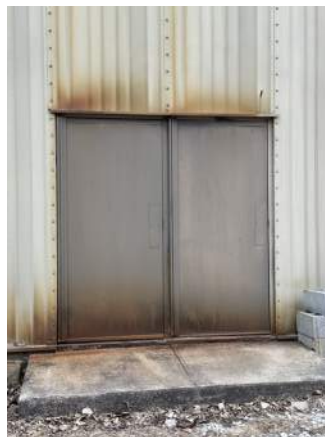
The exterior of the High School and North Elementary building have several instances of wear and deterioration to the façade. Paint is worn or missing from the walls, soffits and flashing components. Rust has accumulated in certain areas. There are instances where the soffit, flashing or wall panels are damaged.

Repair and replace damages to exterior façade. Consider removing rust and repainting where necessary.

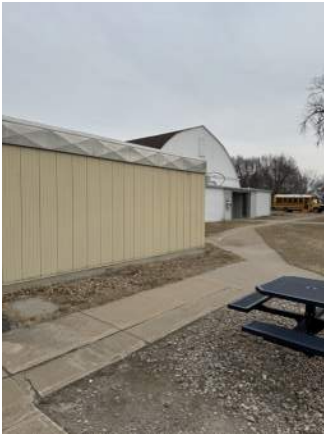
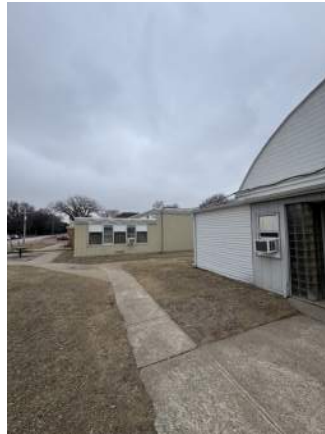
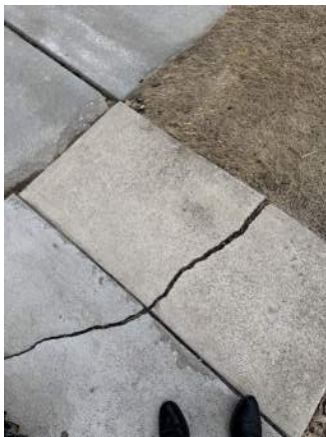
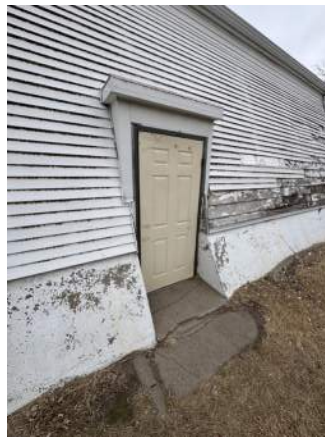
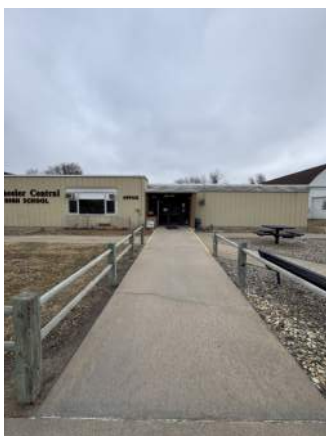
The concrete sidewalks in some instances are old or cracked.

Replace concrete sidewalk.

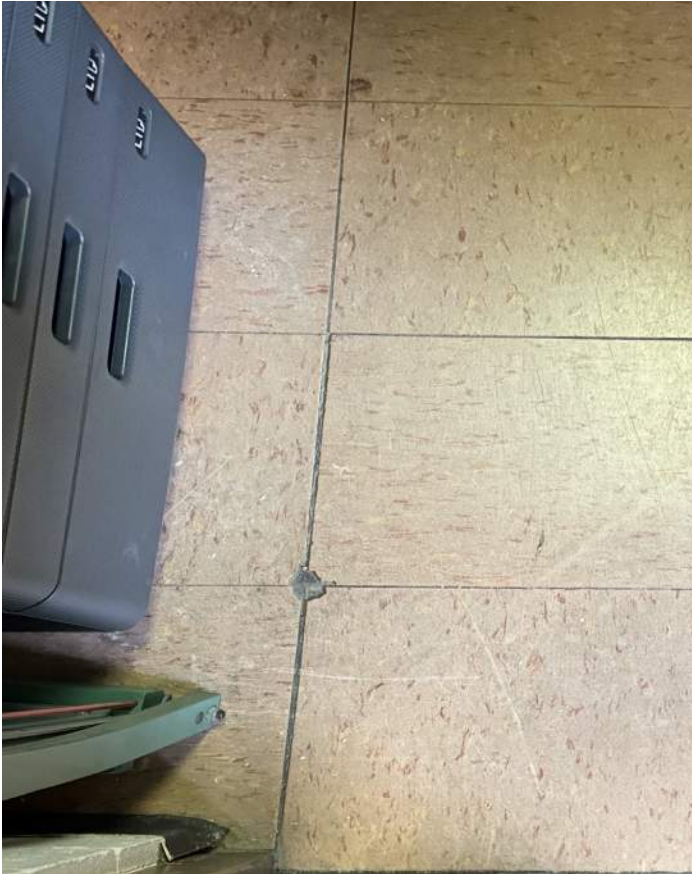
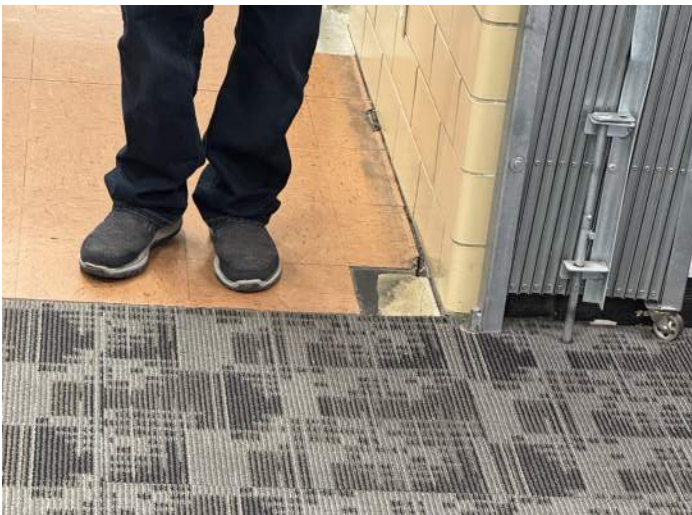
Tiles are damaged in a couple instances in the facilities.

Replace damaged tiles.

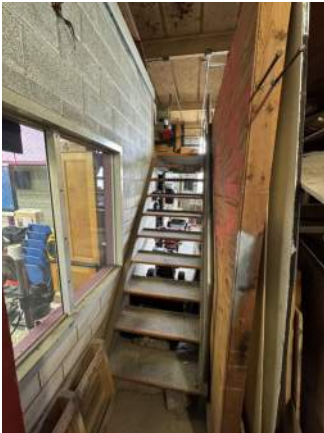
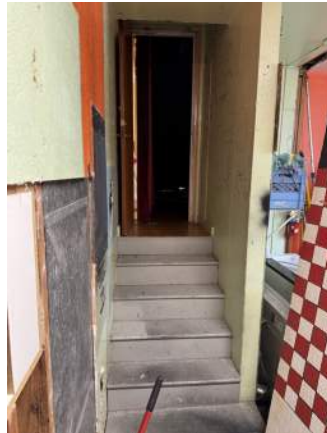
Stair railings are loose, missing or do not comply with the current code.

Install railings where missing and repair loose railings. Replace railings to comply with current code.

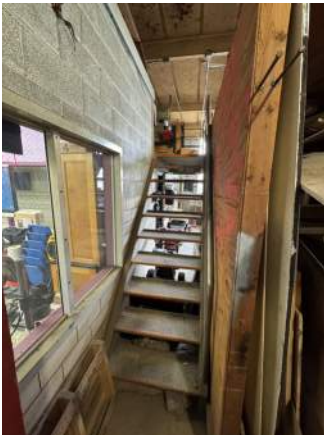
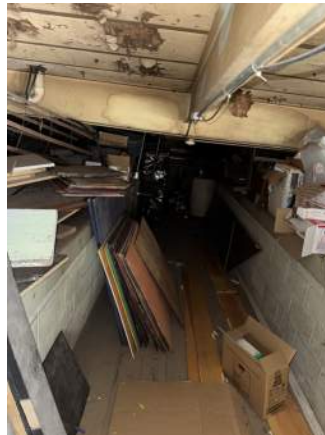
The shop storage mezzanine is cluttered and potentially unsafe.

Organize and clean the mezzanine storage and replace wooden flooring in walkway.

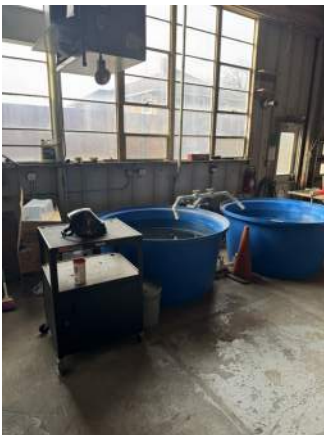
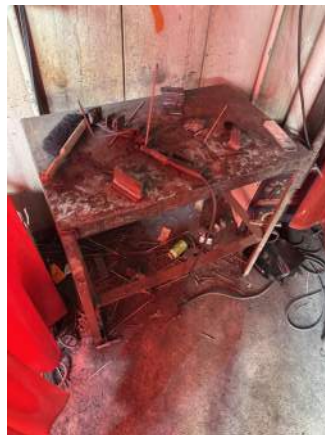
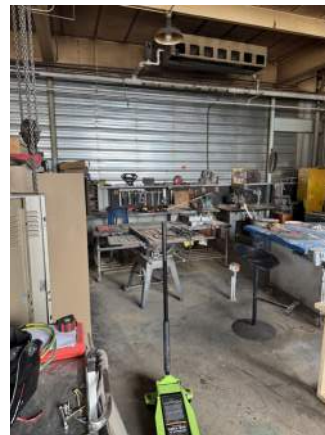
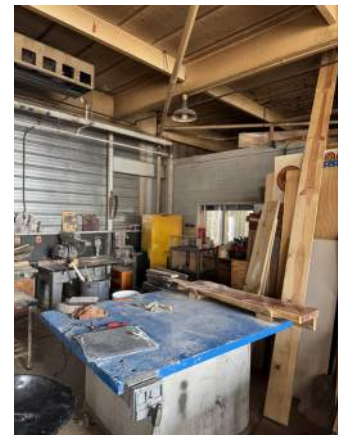
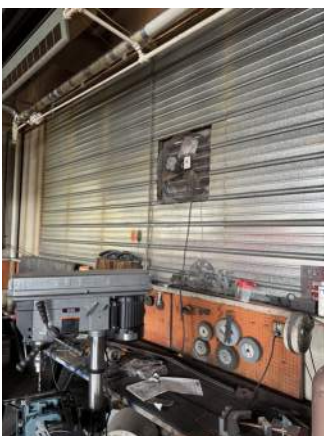
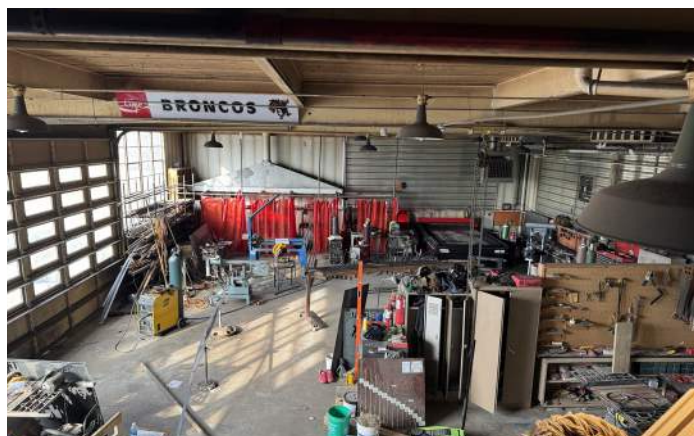
The shop is cluttered with no circulation paths. Machinery clearances are too close together, creating an unsafe environment. Conduit and receptacles are extruding from the concrete floor creating tripping hazards around machinery where apparent circulation paths exist. Welding booths and CNC plasma table area lack proper working space and storage. Areas around the welding booths are restrictive to movement of large pieces of metal and have large amounts of waste on the floor.

Shop space needs reorganization and a new layout for proper circulation and equipment use. Floors need cleaned and waste needs to be removed. Remove or augment exposed floor conduit to eliminate tripping hazards.

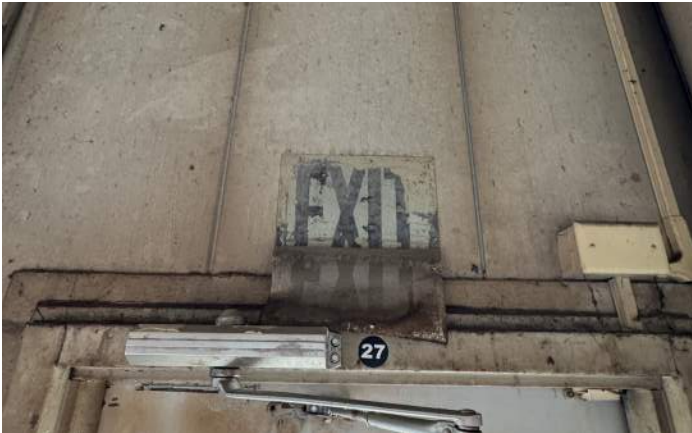
There are multiple exit locations that have damaged or missing exit signage.

Replace all damaged or missing exit signs to comply with the current code. Test existing signage for illumination.

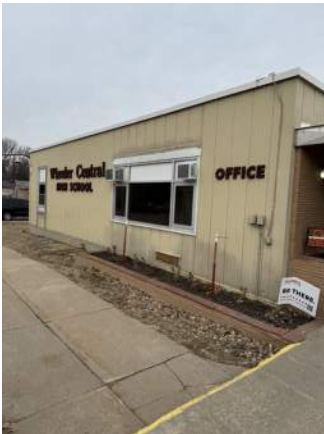
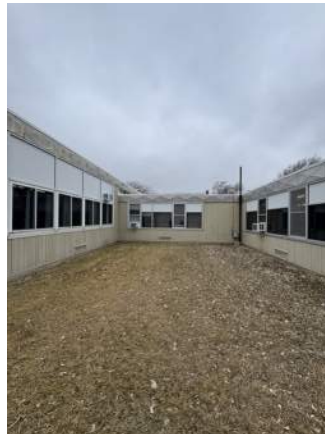
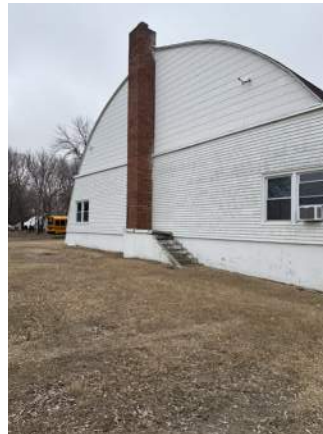
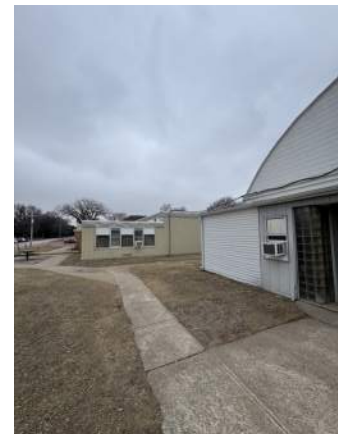
There are two instances of cracked mortar along CMU.

Clean cracks and seal.

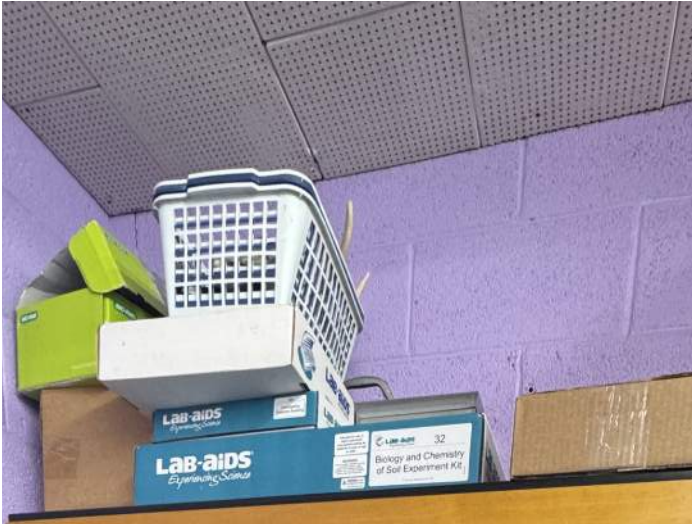
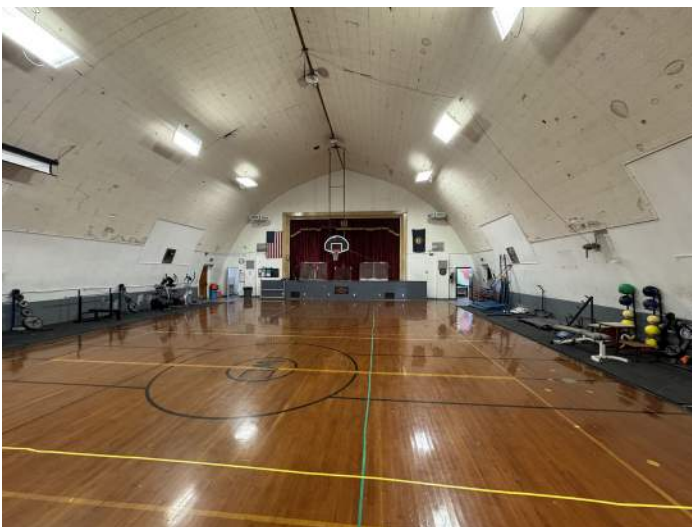
In the gym, ag classroom, and connection link, there is outdated ceiling tile that is stained, damaged, and falling off of the ceiling.

Remove and replace ceiling tiles.

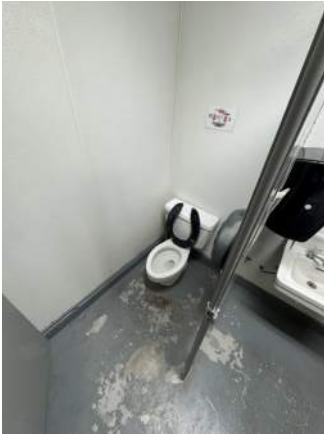
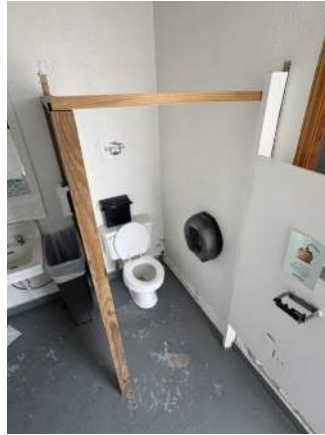
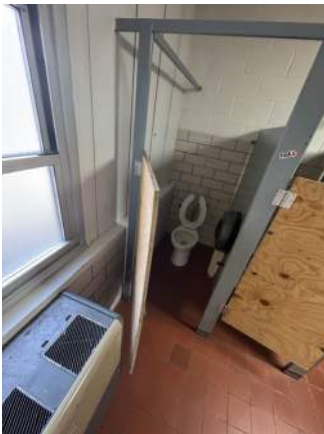
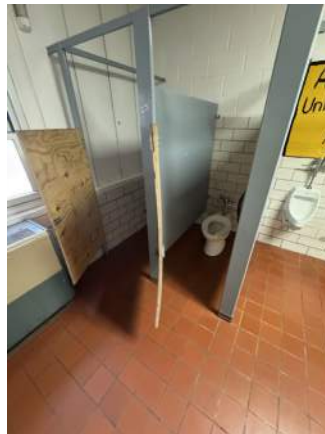
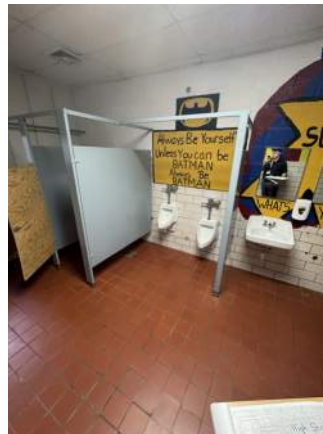
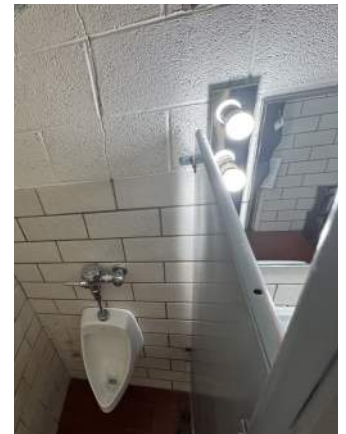
Bathroom partitions are outdated.

Replace all outdated partitions.

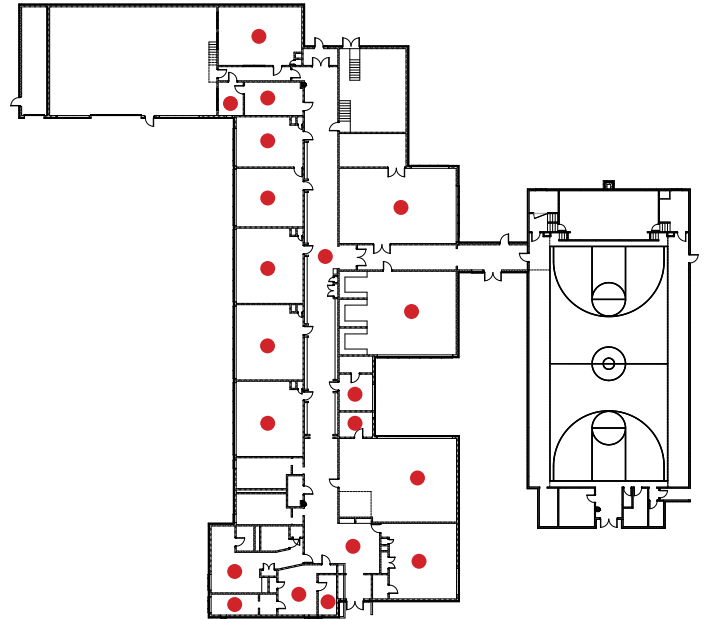
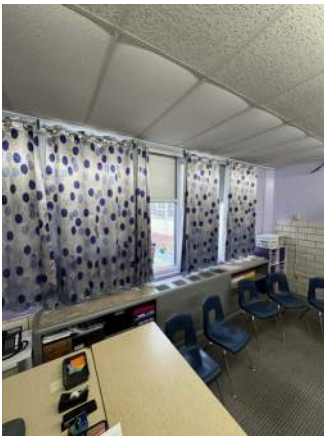
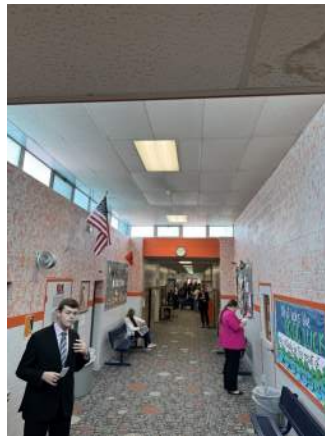
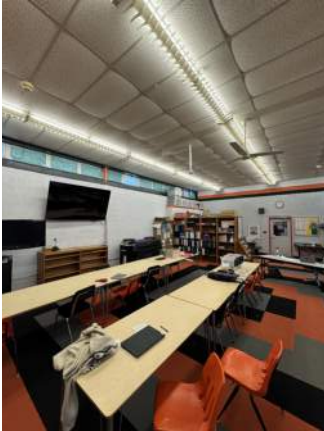
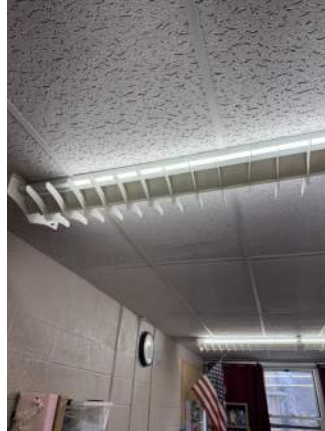
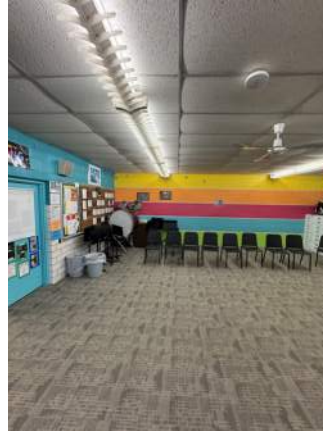
A majority of the acoustic ceiling panels in the high school building are damaged, stained, sagging, or missing.

Replace ceiling panels in their entirety.

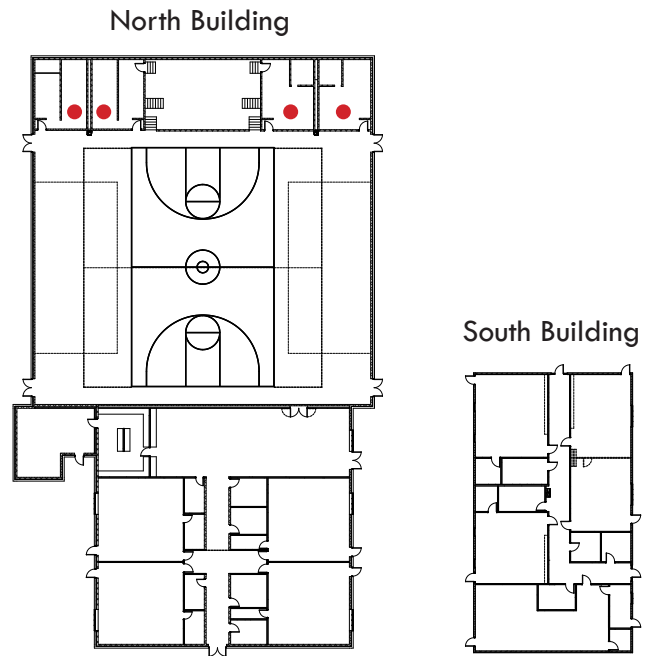
The existing upper-level storage above the stage in the North Elementary building has a 1/2" plywood deck throughout both rooms creating a potentially concerning condition. Walking on the flooring causes noticeable displacement decking. Certain areas with heavy storage are largely exceeding 1/2" plywood load capacities.

Replace 1/2" plywood with 3/4" plywood tongue and groove and properly support.

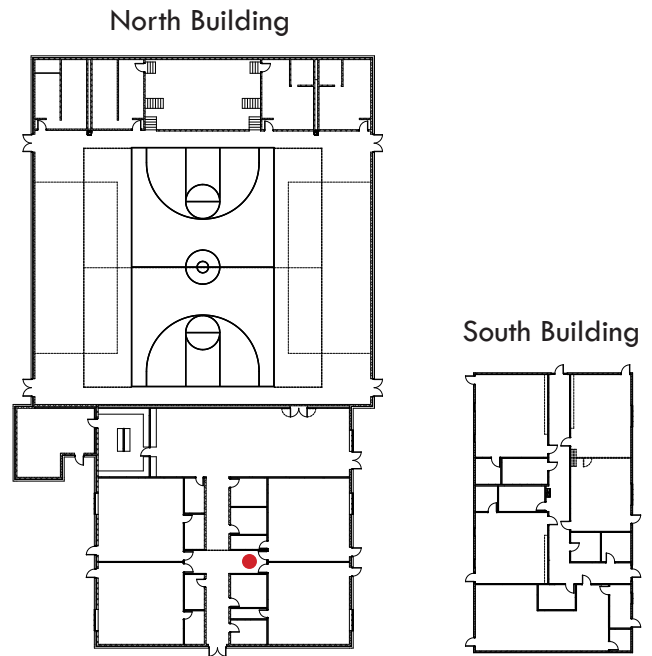
Wall base in some instances is missing, torn away, or damaged.

Replace wall base.

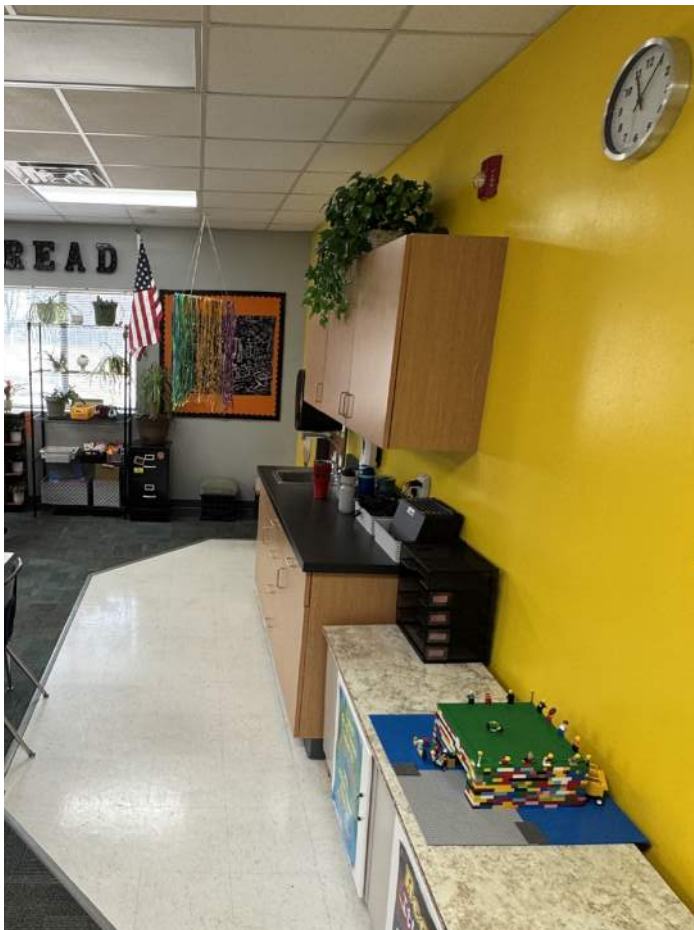
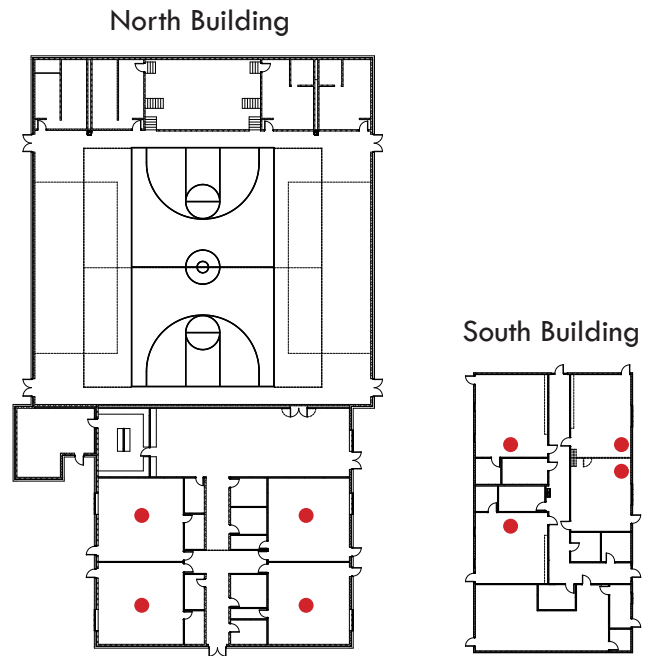
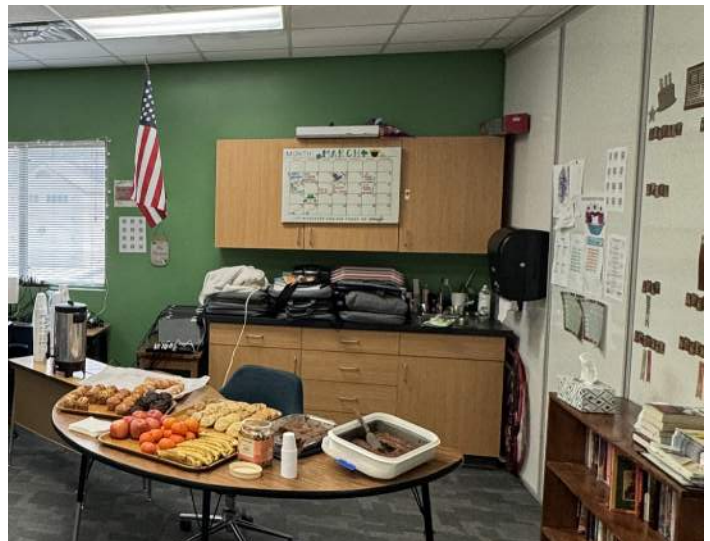
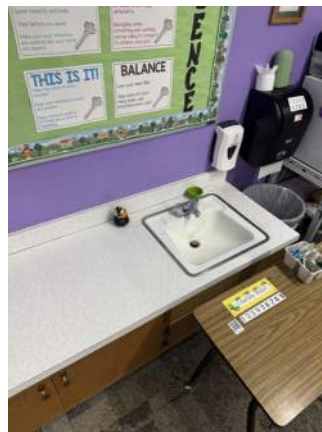
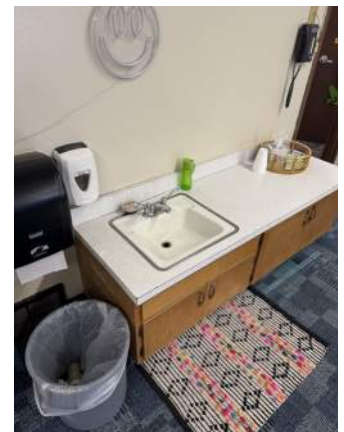
Existing casework in several classrooms is old and has significant signs of wear and chipping. Some instances of classroom casework are underutilized or too tall for the dedicated age group of students occupying the space.

Replace all casework and sink units where necessary.

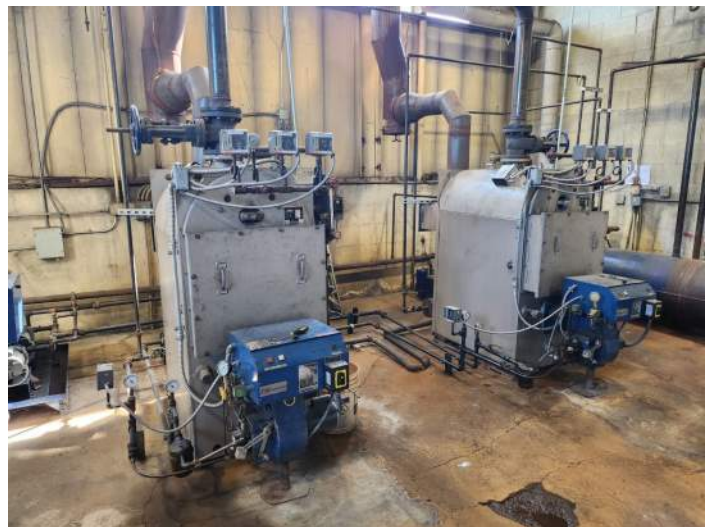
**LOW-PRESSURE STEAM BOILERS**

The original high school building is heated by a low-pressure steam system that has steam supplied from two Aldrich/LES boilers producing 1,000 MBH of heating each. These two boilers were both installed in 2007. The two boilers are fueled from an exterior, buried diesel tank. The diesel tank and associated fuel piping has been replaced in recent years. A louver is installed to provide combustion air into the main boiler room. The current steam pipes are routed through a tunnel that extends around the perimeter of the high school building and the piping insulation appears to have fittings with asbestos. Low pressure steam is routed to several 1954 original Modine cabinet unit heaters throughout the building that provide heating. The boilers do have an emergency shutoff switch outside of the boiler room.

New central heating and cooling should be considered to serve the entirety of both spaces. It would be possible to keep the existing steam boilers, but a hot water heating system should be considered. The transition from window air conditioners to a more efficient central cooling system would reduce annual utility costs.

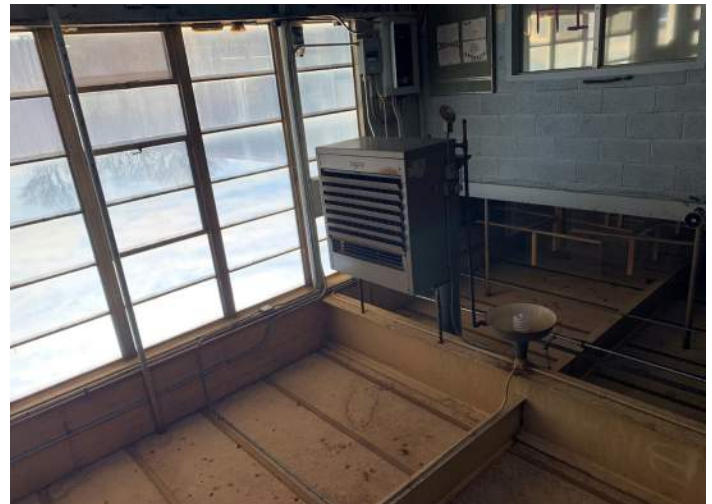
PROPANE SHOP HEATER

The shop space has primary heating coming from propane Hastings unit heaters. These heaters were installed after original construction. The original steam heaters on the north side of the shop appear to be shut off and abandoned. There is a wall-mounted exhaust fan on the north wall of the shop. It has been installed after the original building and has been recently repaired by maintenance staff. It is estimated that the exhaust fan does not provide enough exhaust air to adhere to current ASHRAE Indoor Air Quality Standards. The welding fume hood also appears to have been provided with the original building. The hood is too small to serve additional welding booths that have been constructed. Currently, the only fresh air entering the shop space occurs when the exterior door is propped open. It was discussed that welding fumes have previously entered the main corridor of the high school. The shop classroom is also conditioned with a PTAC unit. The unit appears to be approximately ten years old and the unit's chassis has damage to it.

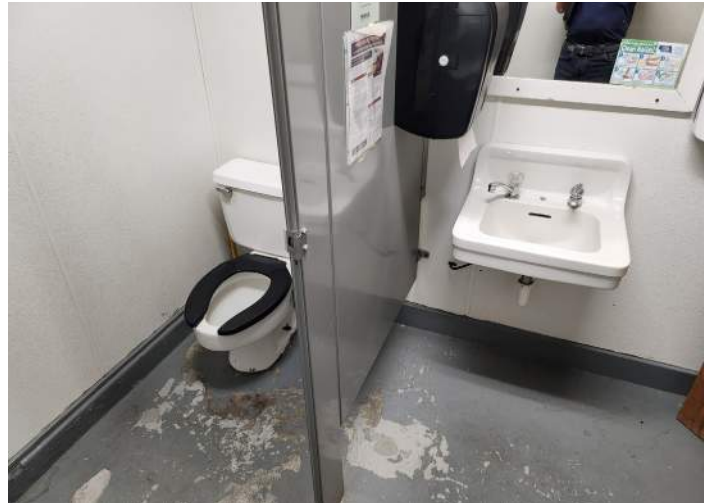
**GYM RESTROOM FIXTURES**

The restrooms in the high school building have been upgraded and fixtures appear to be in good condition.

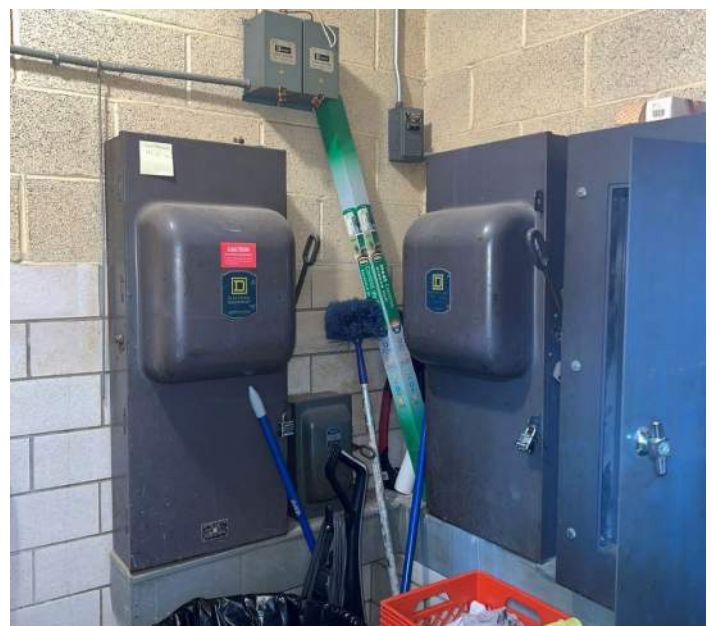
**MAIN DISCONNECTS**

Two 400-amp disconnects are present within a janitor closet that appear to serve as the main electrical disconnects for the building. One main disconnect appears to serve a 400-amp Square D distribution panel, in the same room. The second main disconnect is believed to serve the 400-amp Westinghouse distribution panel in the old gym. Both disconnects are original to the 1954 building and the manufacturer is Square D. Utilization voltage is 240V, 1-phase, 3-wire. A single point grounding system, bonded to all available grounding electrodes does not appear to have been provided as required by current codes. Documentation noting the available fault current at each disconnect has not been provided. Short circuit current ratings (SCCR) could not be determined.

Power distribution panels, branch circuit panelboards, and the existing infrastructure is past it's useful life. Therefore, a complete replacement with a service upgrade will be required for any renovation or addition project.

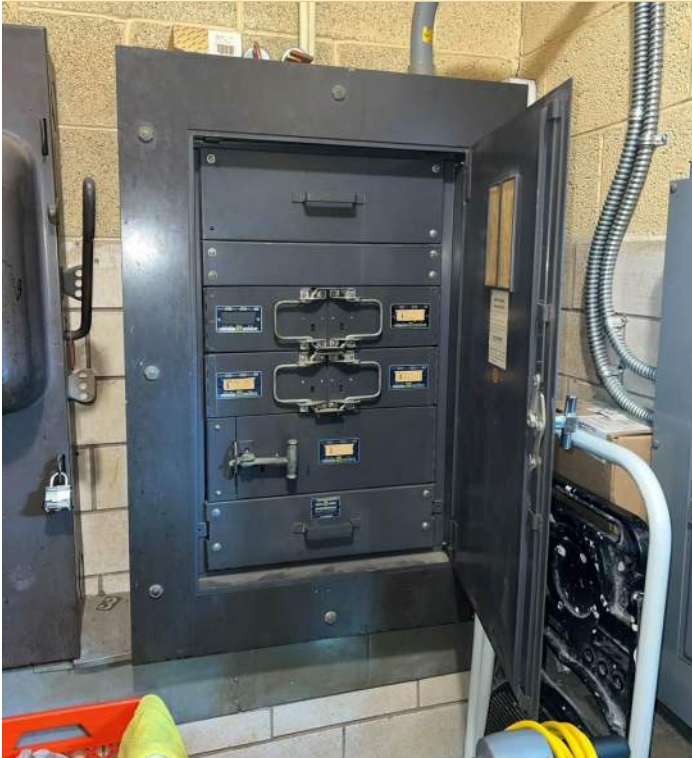
HIGH SCHOOL DISTRIBUTION PANEL

Distribution panels and lighting and appliance panelboards are original to the 1954 building. A few load centers have been added and some panelboards have been retrofitted in place. One load center installed within the entry janitor closet has breakers installed above 6'-7", which does not meet the electrical code. A 1954 vintage 400-amp Square D distribution panel is present in the janitor closet with the main disconnects that appears to serve panelboards throughout the high school. The old gym has a 400-amp Westinghouse distribution panel that appears original to 1950. Physical capacity for expansion does not appear to be available. Breaker kAIC ratings were not visible. Circuit directories were missing on most panels.

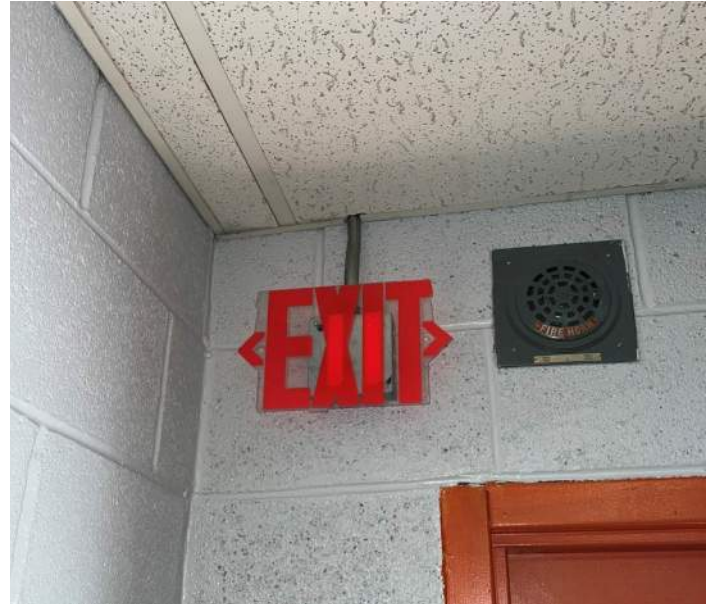
**NON-ILLUMINATED EXIT SIGN**

Exit signs are present throughout the building, but deficient in coverage. Some exit signs consist of non-illuminated signage or older models with incandescent lamps.

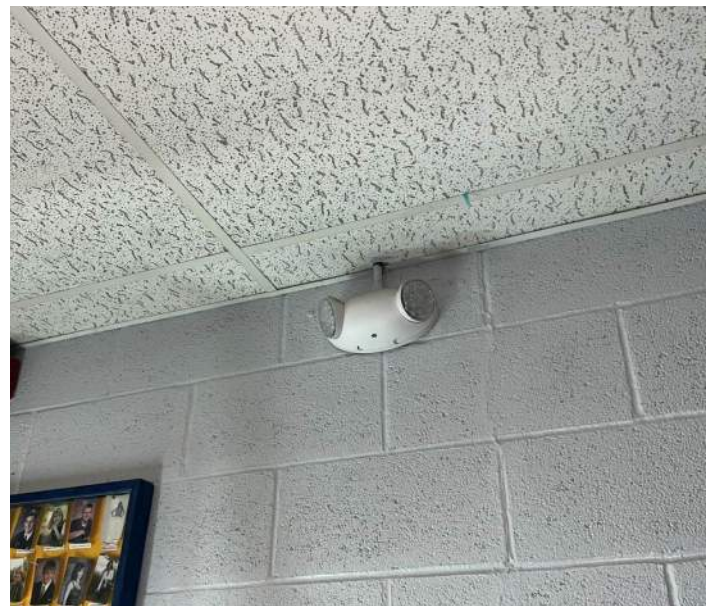
**EMERGENCY LIGHTING UNIT**

Emergency lighting was found to be provided by emergency lighting units with adjustable LED lamps, but coverage was deficient. Interior emergency egress lighting and the quantity of exit signage is not adequate in several areas. Exterior emergency egress lighting does not appear to be provided, as required by current codes.

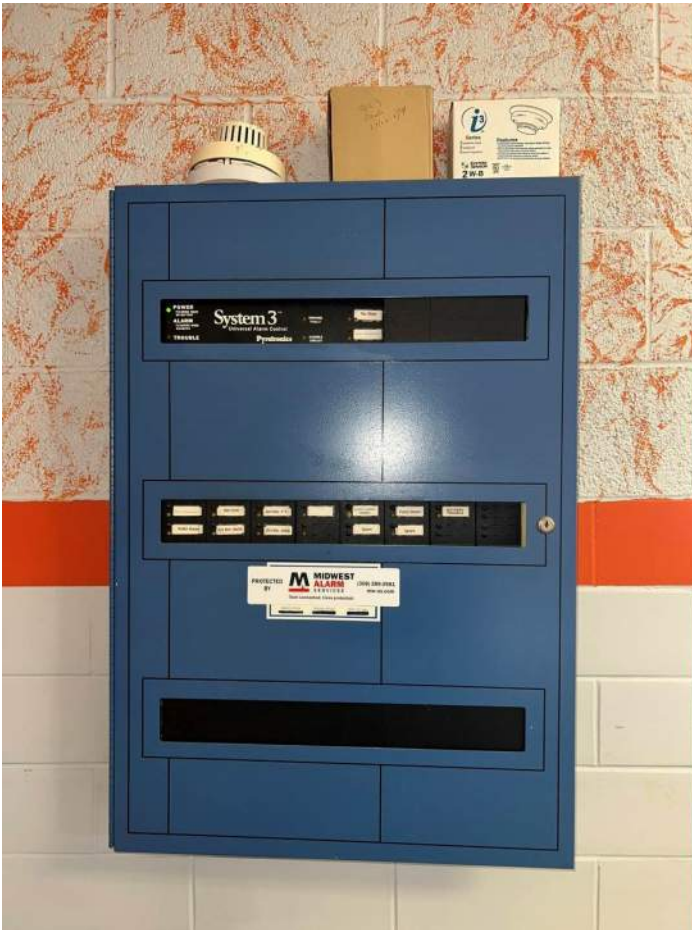
HIGH SCHOOL FIRE ALARM PANEL

The fire alarm system is an older Pyrotronics model that is no longer supported. Fire alarm devices present in the building include smoke detectors throughout the corridors, manual pull stations at every exit door, and audible/visual devices throughout corridors. However, it does not appear that the system has a voice evacuation system, as required per current codes, nor is notification provided in classrooms or other areas outside of the corridors.

A voice evacuation system is recommended to be added to an upgraded fire alarm system, along with additional devices to provide a code compliant system that also meets ADA requirements.

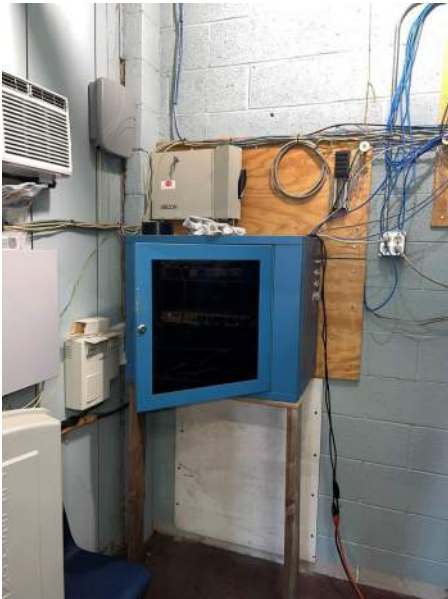
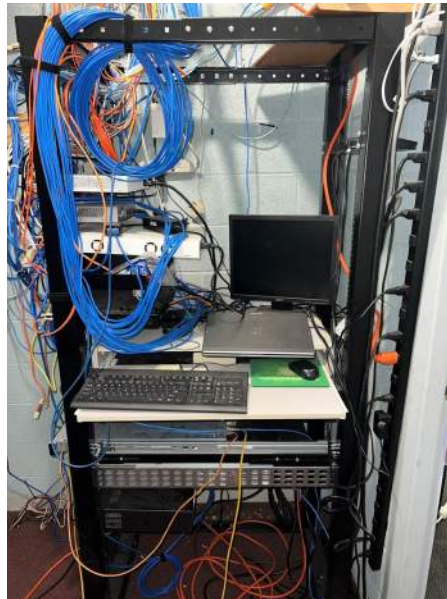
**HIGH SCHOOL DATA ROOM WITH WALL RACK**

There is a wall mounted data rack and a floor mounted data rack in a classroom closet near the front of the building. This location serves as the communications service entrance and Main Distribution Frame (MDF) for the building. CAT 5 cabling is present. The room does have a dedicated cooling unit.

The existing structured cabling infrastructure and cabling installation methods do not meet current BICSI standards. Wi-Fi is provided throughout and is the primary means of data distribution throughout the facility.

Modifying the existing data racks and cable installation to be BICSI compliant would be recommended to improve on the efficiency and growing needs of the technology requirements of an education facility. A dedicated telecommunications room for each building is recommended for building security and ease of access for current maintenance as well as ease of expansion in the future. Cabling is recommended to be replaced with CAT 6, at a minimum.

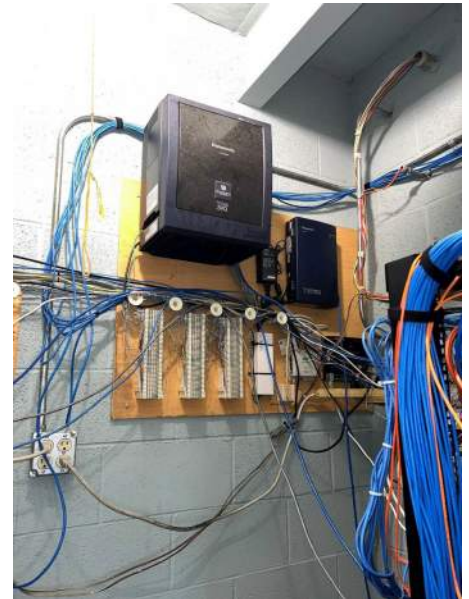
**WALLBOARD WITH PHONE SYSTEM**

A Panasonic analog phone system is present that is no longer supported. Staff noted the phone system will soon be upgraded to VOIP.

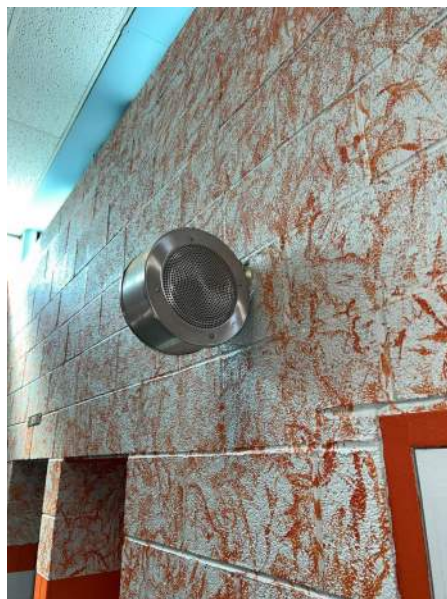
**HIGH SCHOOL TYPICAL CORRIDOR PAGING SPEAKER**

A Viking based paging system is present with original speakers in the corridors and some classrooms. Coverage is deficient. Paging is initiated through the phone system.

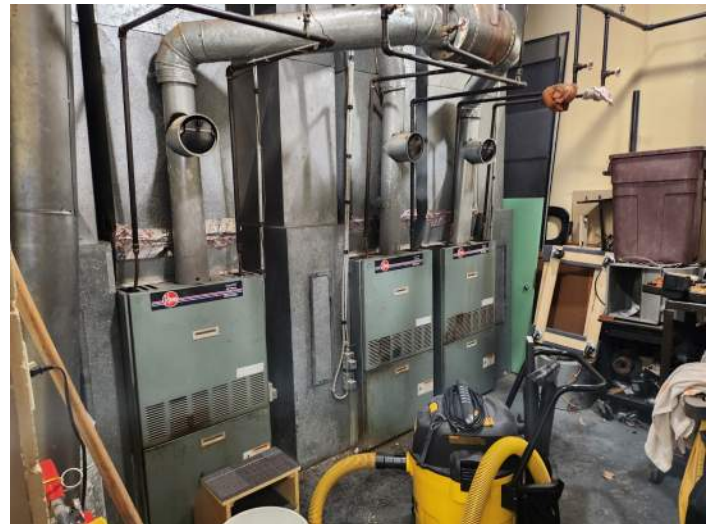
**1978 CLASSROOM AND CAFETERIA DIESEL FURNACES**

The cafeteria space, and four classrooms are split into three zones and served by three original Rheem diesel fuel fired furnaces. The three furnaces are well past their serviceable lives. There are currently some leaks in the fuel piping serving these furnaces. The kitchen and storage room does have cooling capacity from a condensing unit on the west side of the building. Similar to the high school, each classroom is provided with window air conditioning units.

The three diesel furnaces should be considered for replacement. If they are to be replaced with similar units, outdoor air should be supplied to the units directly to avoid atmospheric venting inside the mechanical room.

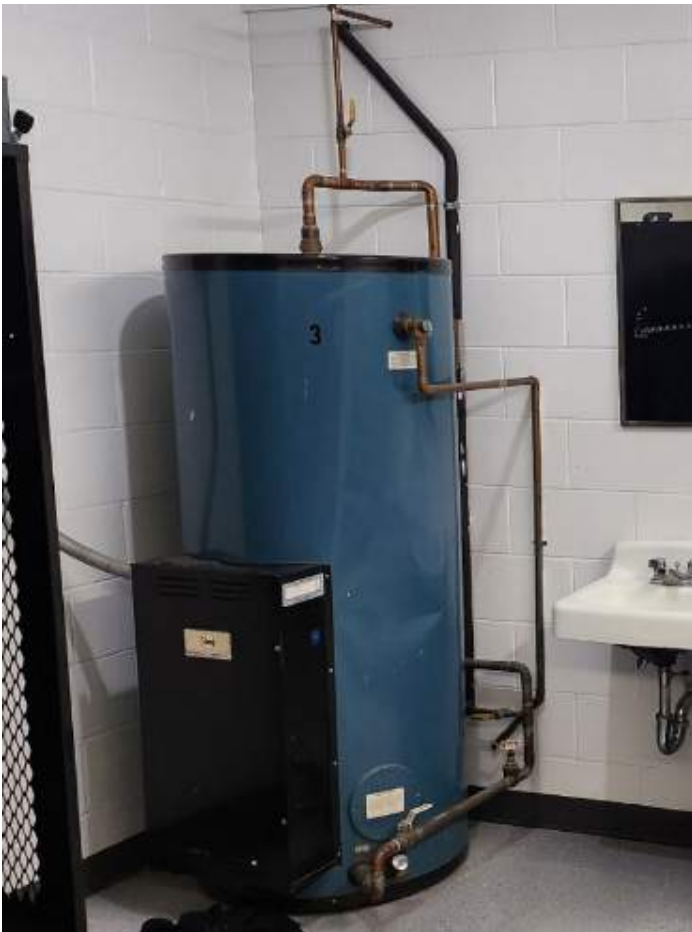
**ORIGINAL 1978 GYM WATER HEATER**

Each building appears to have a dedicated water service with a meter, but no backflow preventer. The 1978 building has original copper piping running throughout. PEX water piping was observed where patches were required and to serve the updated kitchen space. There appears to be some piping insulation on copper hot water piping, but it is in poor condition. There is no piping insulation on any PEX piping located in the building. The building has two original 27 KW electric water heaters, which appear to have been manufactured in 1976. They appear to be in good condition, but are well past their serviceable life.

The water heaters should also be considered for replacement. Currently, a 49-year old water heater is serving the kitchen that serves both buildings.

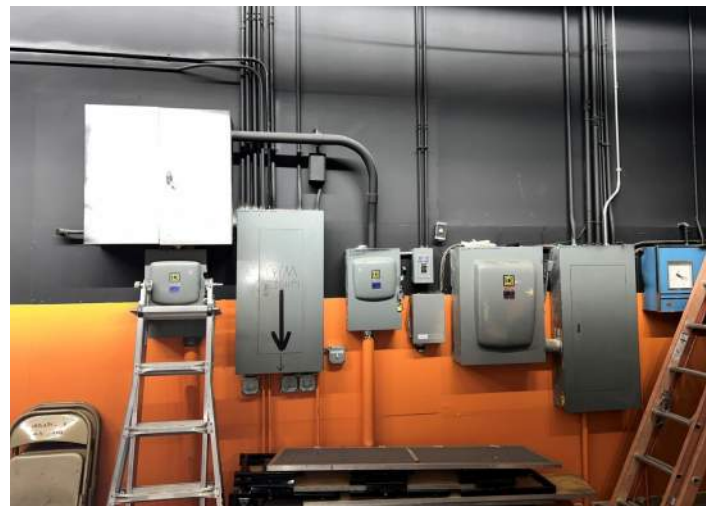
The 1978 gym building is served by a utility company pole-mounted transformer, located on the north side of the building. The secondary electrical service extends overhead, from the pole-mounted transformer to a large splice cabinet at the back wall of the stage. Four (4) main disconnects for the gym facility are present that vary between fused disconnect switches and panelboards with main breakers. Utilization voltage is 120/208V, 3-phase, 4-wire. A single point grounding system, bonded to all available grounding electrodes does not appear to have been provided as required by current codes. Documentation noting the available fault current at each disconnect has not been provided. Short circuit current ratings (SCCR) could not be determined.

**NEW GYM BUILDING MAIN DISCONNECTS**

Square D equipment is present for disconnect switches and panelboards throughout the gym and appear to be original to 1978. Equipment appears to be in fair condition. Typewritten circuit directories are not present.

Power distribution panels, branch circuit panelboards, and the existing infrastructure is past its useful life in the 1978 gym/elementary building and are recommended to be replaced/upgraded as part of any future work. Additionally, the (4) main disconnects present do not meet current codes. It is recommended for the electrical service to be upgraded to a usable voltage that would allow a reasonably sized single main building disconnect.

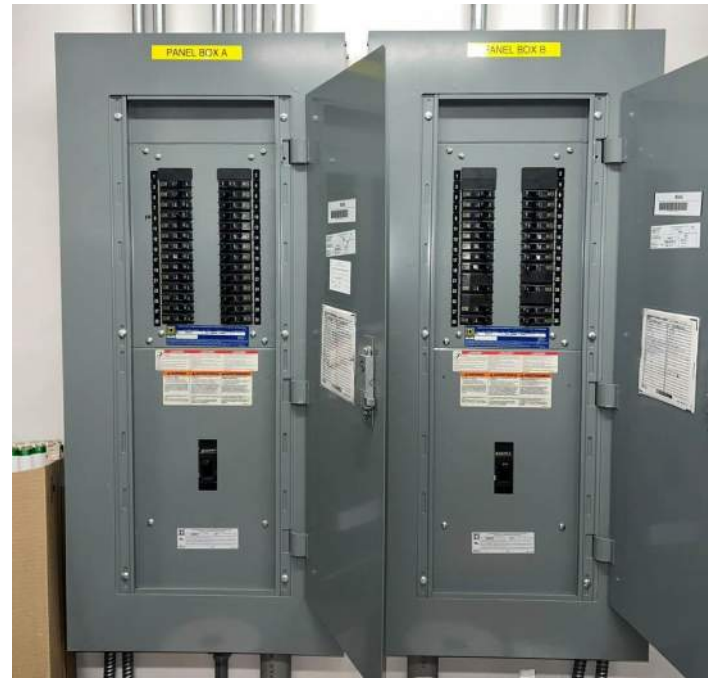
The 2010 building is also served by a utility company pole-mounted transformer, located along the east side of the building. The secondary electrical service extends underground, from the pole-mounted transformer to two panelboards, each with a main breaker, that serve as the building main disconnects. Utilization voltage is 120/240V, 1-phase, 3-wire. A single point grounding system, bonded to all available grounding electrodes does appear to have been provided. Documentation noting the available fault current at the panels has not been provided. Short circuit current ratings (SCCR) are visible.

The service entrance panelboards also provide power distribution throughout the 2010 building. This equipment appears to be in good condition. Square D equipment is present for disconnect switches and panelboards throughout and appear to be original to 2010. Equipment appears to be in fair condition. Typewritten circuit directories are present.

**2010 ELEMENTARY SCHOOL BUILDING ELECTRICAL SERVICE ENTRANCE EQUIPMENT**

The 2010 building's power distribution is in good condition and no upgrades are recommended at this time.

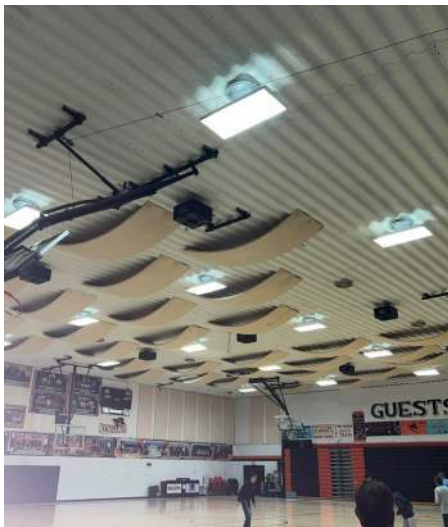
Fluorescent lighting was used throughout most of the interior of the 1978 gym/elementary building with some newer LED flat panels present. Existing fluorescent based light fixtures have been retrofitted to LED as lamps and drivers fail. The gym has T5HO high bay light fixtures. The 2010 elementary building also has 2x4 T8 fluorescent based light fixtures that have been converted to LED as lamps and drivers fail. The Correlated Color Temperature in both buildings is 4100K.

**TYPICAL LIGHTING IN THE 1978 GYM/ELEMENTARY BUILDING**

Energy efficient LED lighting is recommended to replace any of the remaining fluorescent light fixtures. Lighting controls that include vacancy sensors, occupancy sensors, daylight harvesting and dusk to dawn controls are recommended to be provided as part of a building wide lighting upgrade to satisfy energy codes required by the state. Controls within the 2010 building appear to be code compliant.

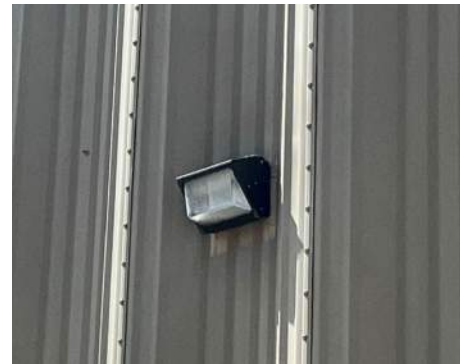
Exterior lighting on the 1978 gym/elementary building consists of building mounted wallpacks, however, their lamp source was not determined. Lighting is not full cut-off. Exterior lighting on the 2010 building consists of recessed LED downlights around the perimeter of the building.

**TYPICAL EXTERIOR WALLPACK ON THE 1978 BUILDING**
