# WHEELER

# CENTRAL

## FACILITIES ASSESSMENT

May 20, 2025

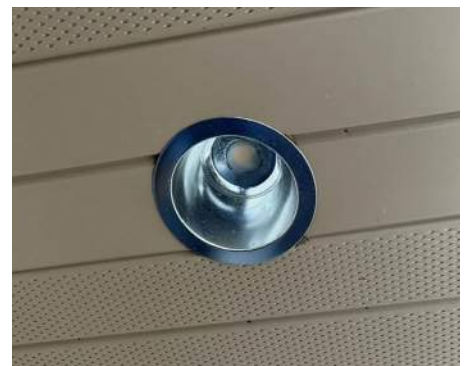
Exterior lighting on the 1978 gym/elementary building consists of building mounted wallpacks, however, their lamp source was not determined. Lighting is not full cut-off. Exterior lighting on the 2010 building consists of recessed LED downlights around the perimeter of the building.

**RECESSED DOWNLIGHT ON THE 2010 BUILDING**

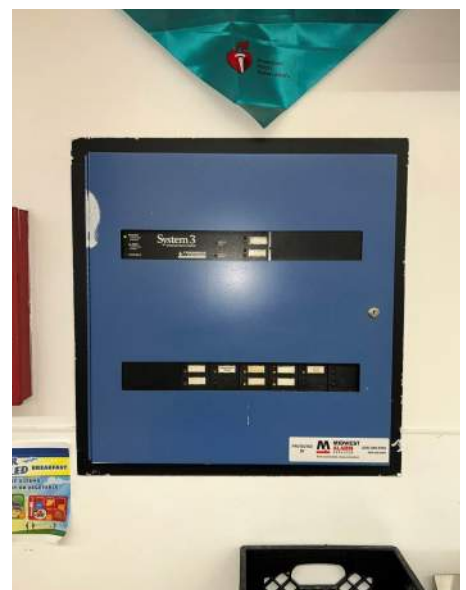
The fire alarm system in the 1978 gym/elementary building is an older Pyrotronics model that is no longer supported. Fire alarm devices present in the building include smoke detectors throughout the corridors, manual pull stations at corridor exit doors, and audible/visual devices throughout corridors. Coverage and detection are missing in the gym and classrooms. Also, it does not appear that the system has a voice evacuation system, as required per current codes, nor is notification provided in classrooms or other areas outside of the corridors.

**EXISTING FIRE ALARM CONTROL PANEL IN THE 1978 BUILDING**

A voice evacuation system is recommended to be added to an upgraded fire alarm system, along with all devices to provide a code compliant system that also meets ADA requirements in the 1978 building. The fire alarm system in the 2010 building appears to meet current codes, therefore, no recommendations are being made at this time for this building.

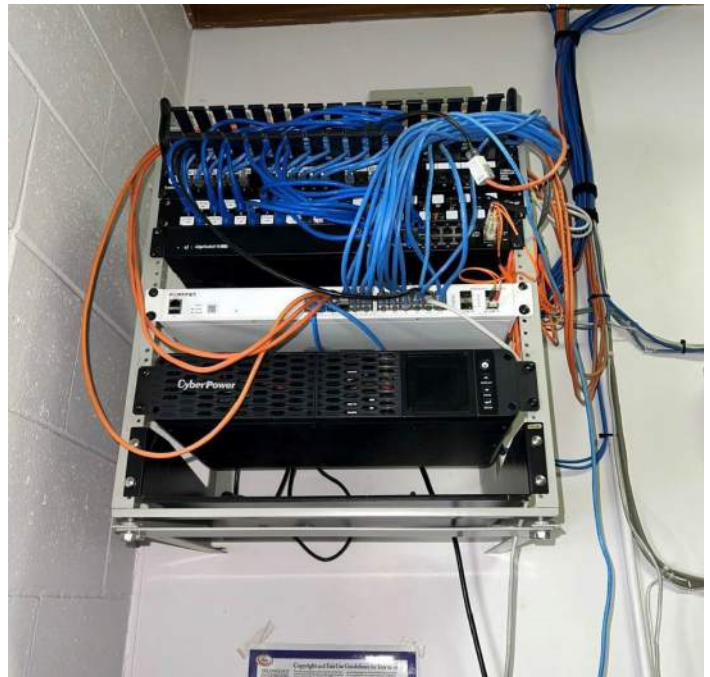
**EXISTING DATA RACK IN THE 1978 BUILDING**

Modifying the existing data racks and cable installation to be BICSI compliant would be recommended to improve on the efficiency and growing needs of the technology requirements of an education facility. A dedicated telecommunications room for each building is recommended for building security and ease of access for current maintenance as well as ease of expansion in the future. Cabling is recommended to be replaced with CAT 6, at a minimum.

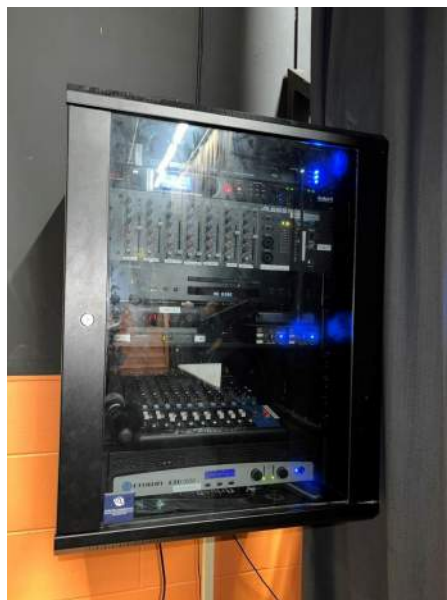
Only the 1978 gym has an audio system present. A modernized system was installed about 6-years ago with newer head end equipment installed in a wall mounted rack on the stage. The gym speakers are original but still in fair condition.

**EXISTING AUDIO EQUIPMENT RACK IN THE 1978 BUILDING**

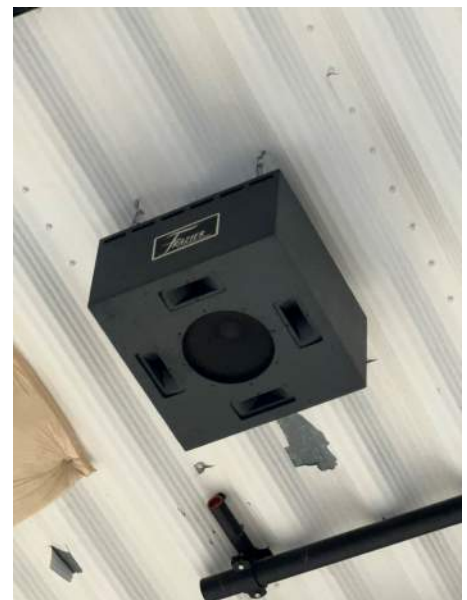
**GYM SPEAKERS**

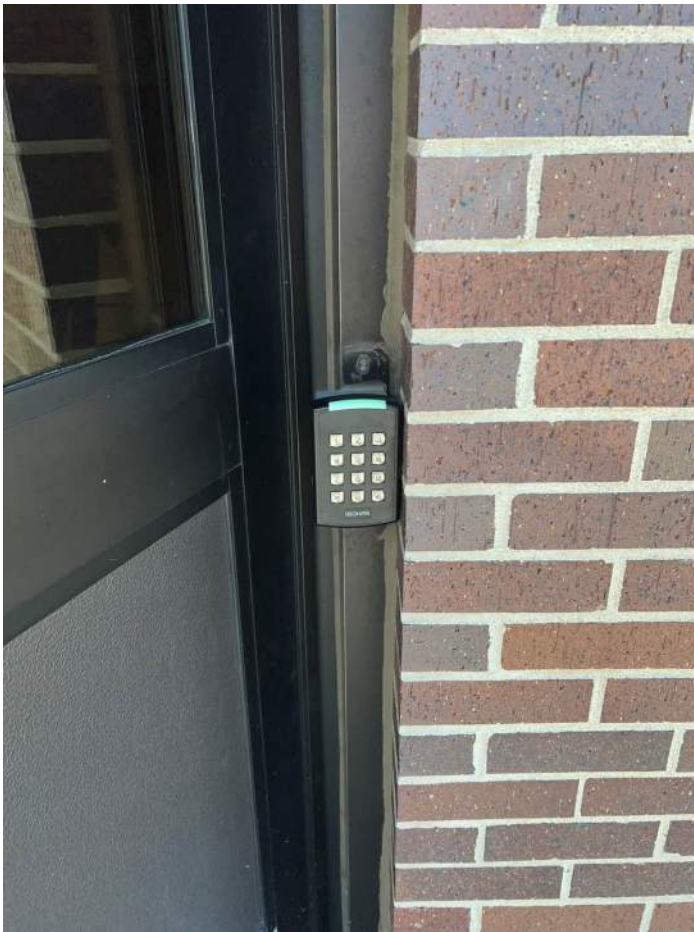
A Wisenet based Access control system is present. Access controls are minimal as keypads with electrified locks are present at entry doors.

**NEWER CARD READER AT AN EXTERIOR DOOR AT THE 1978 BUILDING**

The access control and video surveillance systems are both modern systems that can be readily expanded upon as funds become available. It is recommended to add door monitoring to all perimeter doors to be able to detect an intrusion event and enhance the security of the facility. Replacing existing keypads with card readers would provide a more secure building and is recommended. Video intercom devices are recommended at entry doors for enhanced security.

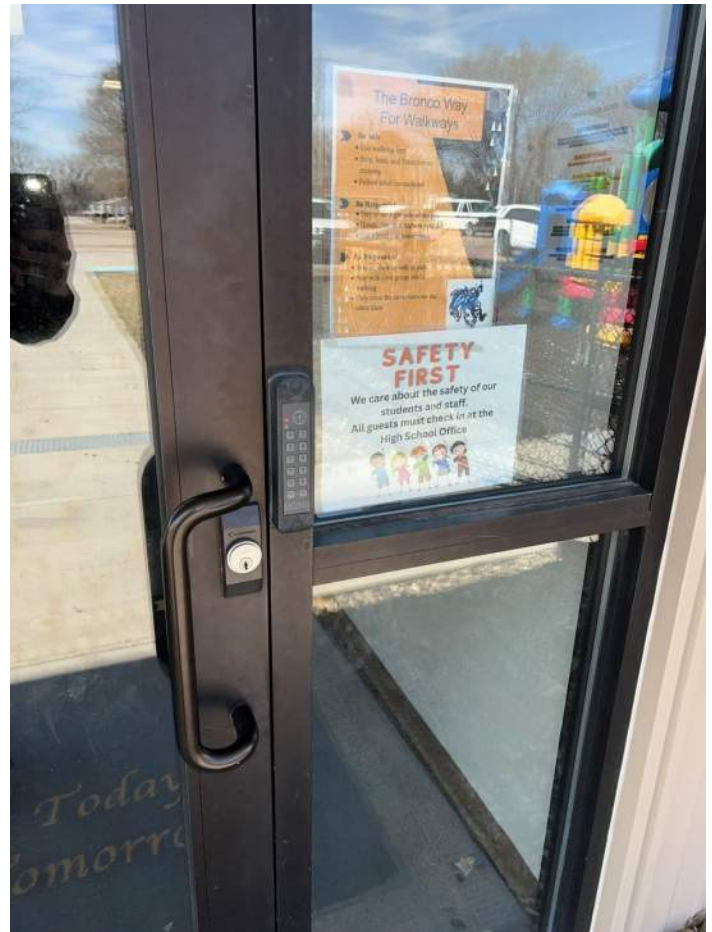
**OLDER KEYPAD ON THE 2010 EXTERIOR DOOR**
